# SCAPA FLOW EASTERN DEFENCES & FLOTTA

## WARTIME TRAIL

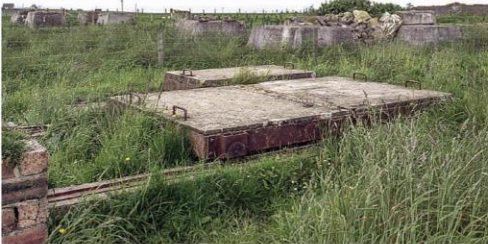
400m to the northeast are two underground backup transmitter and receiver bunkers, they are hidden under massive steel and concrete sliding doors. The electricity supply for Netherbutton came from the engine house sited by the A961, 500m north of the guard-house; still retaining its blast walls, it is now used as a farm shed.

Access hatches for the backup receiver bunker near Northfield Farm in 2016.

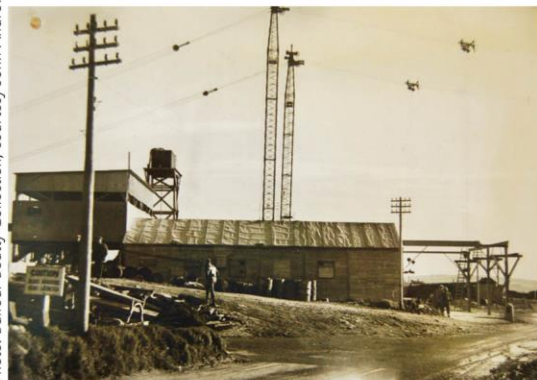
The cement sheds. Rockworks October 1943

The large hut behind you was part a site known as 'Rockworks' which included Balfour Beatty's main offices and workshops, a block fabrication yard, headquarters of the Admiralty overseers and at least 18 accommodation huts. The photograph gives a sense of the vast scale of the operation. There were similar yards at Bossack, Lamb Holm, Warebanks and South Burray; between them they produced over 60,000 concrete blocks, each weighing between 4.8 and 10 tons. [↑](#)

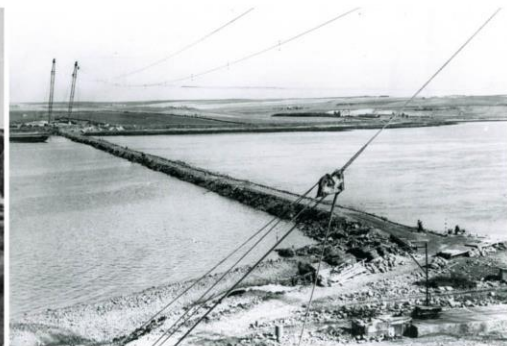
August 1943. The barrier nearing completion as seen from Lamb Holm. Note the aerial ropeways.

The loss of HMS *Royal Oak* resulted in the decision to close the four eastern channels with permanent causeways. Construction began in mid 1940 and was completed by September 1944. The strength of the tidal flows and the depths involved (up to 18m) made the task difficult. Each barrier has a core of loose rubble and 5 ton gabions (wire baskets filled with rock), topped with concrete. These are flanked by 5 ton concrete blocks that are in turn overlaid with 5 and 10 ton blocks placed in a random pattern to break the force of the sea. This project required the construction of a rail network, 3 piers, 5 power stations, 5 blockyards and accommodation for a workforce of over 2000, of whom 1300 were Italian prisoners of war. Seven local quarries provided rock for the production of over 66,000 blocks and an additional 330,000 tons of concrete. The gabions and blocks were dropped into place by aerial cableways, each of which was about 760m long and suspended from pairs of masts some 60m above the ground.

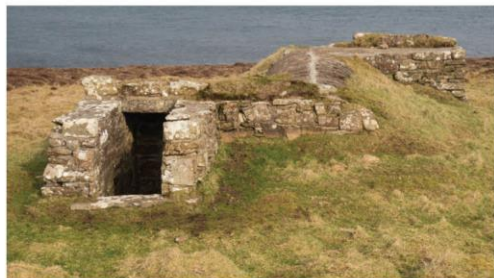
Car park and beach access. From the beach is a good view of the east side of barrier No2, the hulk of a floating crane, and the mast of the SS *Emerald Wings* which was built in 1920 and scuttled in 1940. In the distance, resting against the blocks, are the remains of a ship's engine. Cross the road with care and follow the track above the shore along the course of a railway that ran to Glimps Holm quarry. To your left is a long embankment. 750m further on are a pair of air raid shelters. Below are the remains of a pier.

One of the air-raid shelters. March 2022

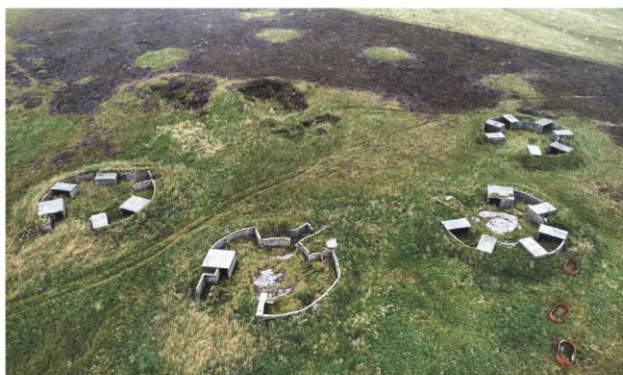
This site can be viewed from Path B4. There were 22 HAA batteries in Orkney during WW2. This one is believed to have been active from 1942. The remains include an arc of four gun-emplacements, each surrounded by ammunition lockers that also acted as crew shelters. The command centre and accommodation camp have been demolished; the extent of the site can be seen on the 1944 aerial photograph. There were four dummy emplacements south west of the genuine ones, an attempt to fool the enemy into thinking that this area was very heavily defended.

Aerial view of Mossbank Battery from the north east. The four round green patches mark the site of the dummy emplacements.

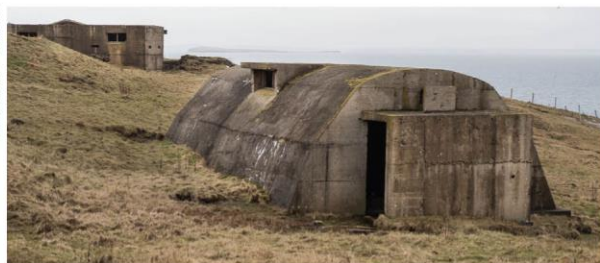
WW2 engine house in a reinforced Nissen hut, Hoxa Battery, 2022

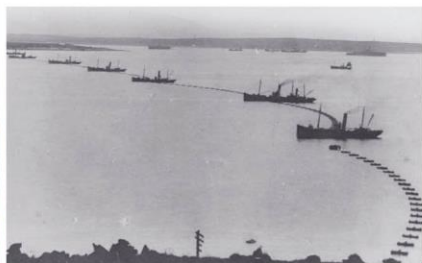
The Hoxa boom and drifters during WW1

Hoxa Sound was blocked by 2.7km booms that stretched between Balfour Battery and Buchanan Battery on Flotta. These consisted of cables, anchored to the shore and supported by floats. They were armed with anti-motor torpedo boat spikes at water level and anti-submarine netting suspended below (see also 14). Moveable sections of the boom were used as 'gates' to allow the passage of shipping; they were operated by small ships. [↑](#)

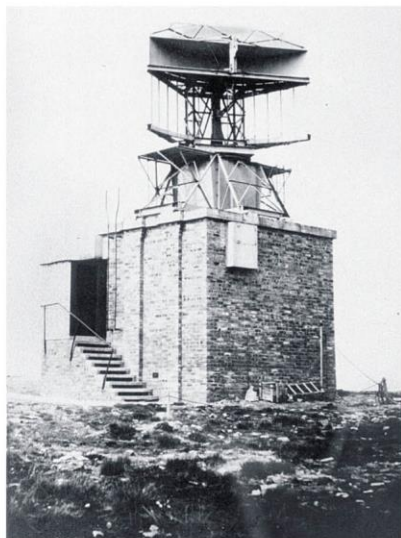
On the highest point in South Ronaldsay and offering spectacular views, this site is accessible via Paths SR6/8 from Windwick Bay or by Path SR8 that leads up from the A961, 50m north of the viewpoint. Dating from 1940, this was No5 in a group of six stations which deployed a series of newly developed radar systems. Most of the buildings have been demolished or modified, though an engine house and its blast screen survive adjacent to the track. The large building to the north probably housed the Chain Home Low unit that became operational in 1943. Other remains include anchor points for aerial masts and the concrete foundations for huts. There are also traces of defensive works such as slit-trenches, and emplacements for anti-aircraft guns and searchlights.

One of the two Type 277 Radars at Ward Hill c.1944

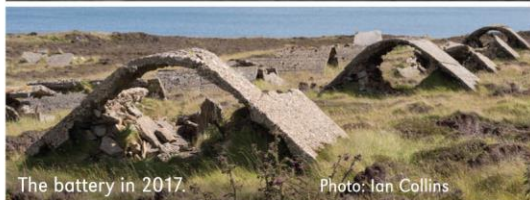
Dating from WW2, this consists of a grid of 64 rocket launching pads each with two tunnel-like ammunition stores made from corrugated iron and concrete. The battery was designed to launch a barrage of projectiles and produce a wall of shrapnel in the path of enemy aircraft. The tunnels gave the crew some protection from falling debris.

The battery in 2017.
